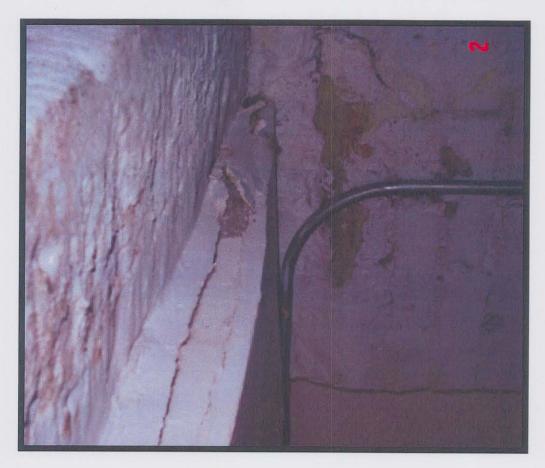
FS 13 – Areas where no cleaning has taken place allowing for harborage of pests like fruit flies, house flies and roaches

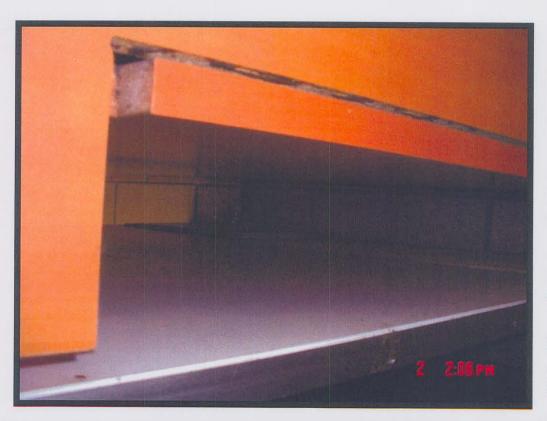
FS 15 – Ceilings and walls in the basement are not properly maintained. Visible cracks and peeling plaster and paint were observed.

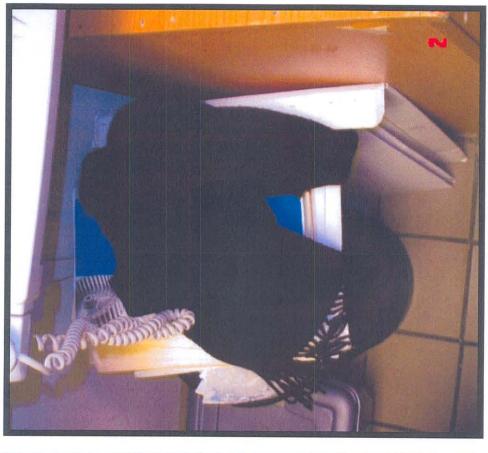
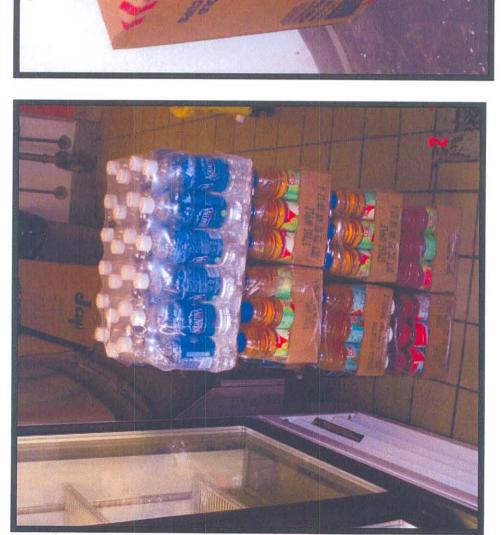
FS 13 – Areas where no cleaning has taken place allowing for harborage of pests like fruit flies, house flies and roaches

space allowed to ensure proper cleaning
